# *Safeguard Home Inspection LLC*

## Property Inspection Report

1700 41st Ave, Anytown, WI 12345  
Inspection prepared for: Joe Smith  
Real Estate Agent: Private sale inspection -

Date of Inspection: 8/23/2018 Time: 8:00  
Age of Home: 2007 Size: 2744

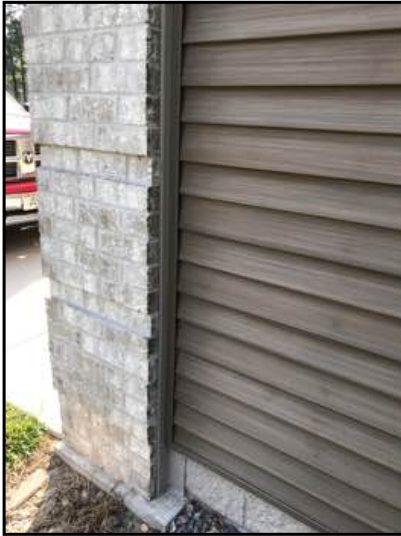
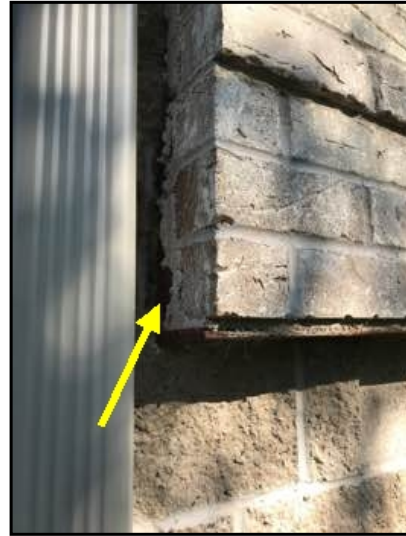
Gap in mortar. SW corner.

- No major system safety or function concerns noted at time of inspection.
- Caulk and seal all gaps, cracks and openings.

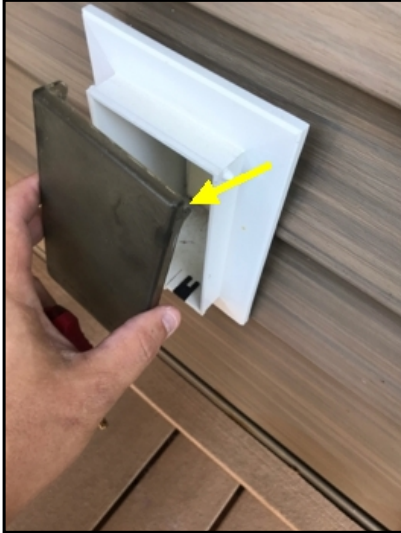
Deck outlet cover is damaged.

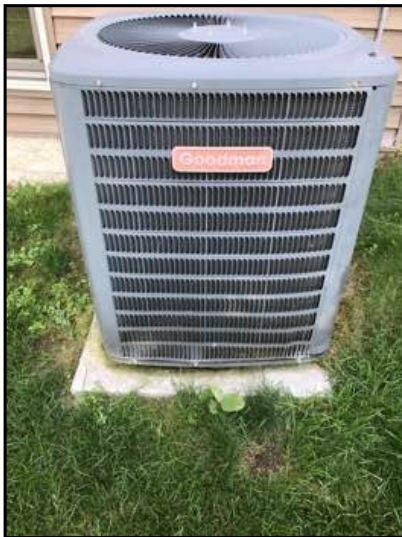
West.

- **LOCATION(S):**
- West side of house.
- **CONDITION:**
- Unit is level.
- Dirty. Recommend removing grass and vegetation from the unit to increase efficiency.
- Functioning at the time of inspection.
- The average service life for **A/C** unit is 10-15+ yrs. Although some last much longer with proper maintenance and yearly service. This report is not a guarantee of the life expectancy of this unit.

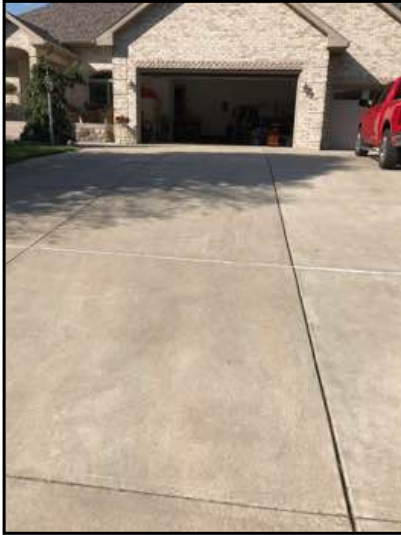
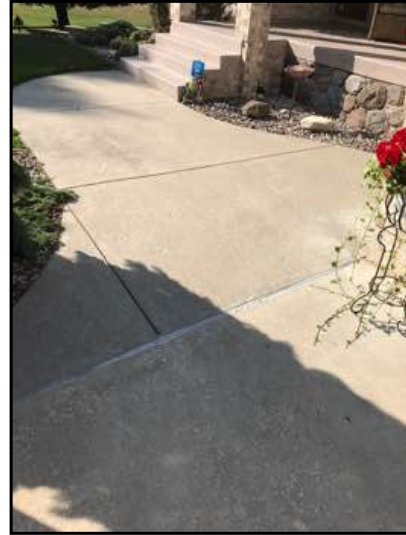
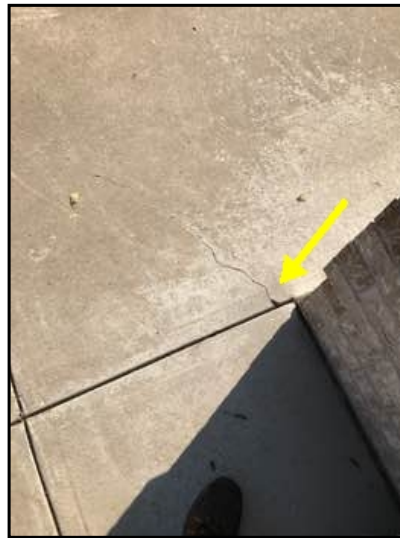
Small settlement crack at single garage door entry.

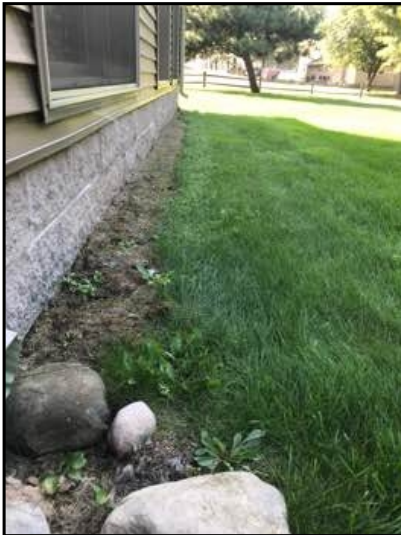
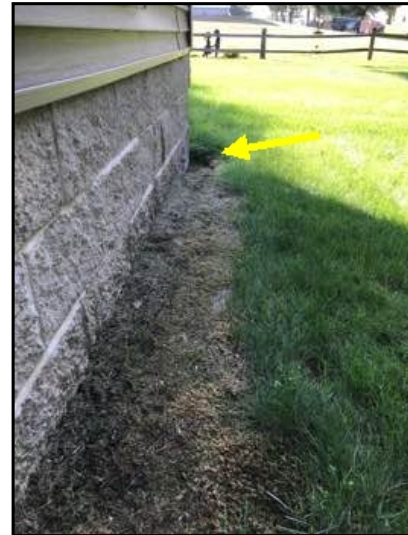
Small depression. NW. Back fill recommended.

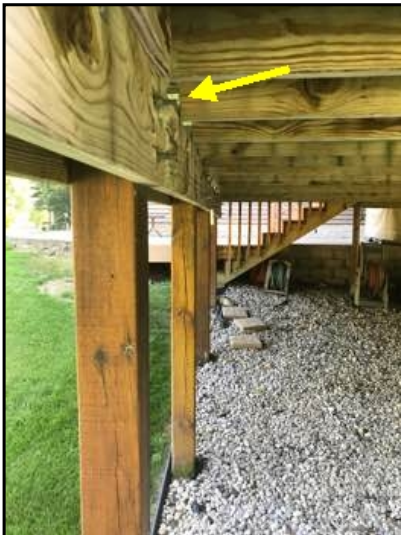
Lag bolted through vertical supports.

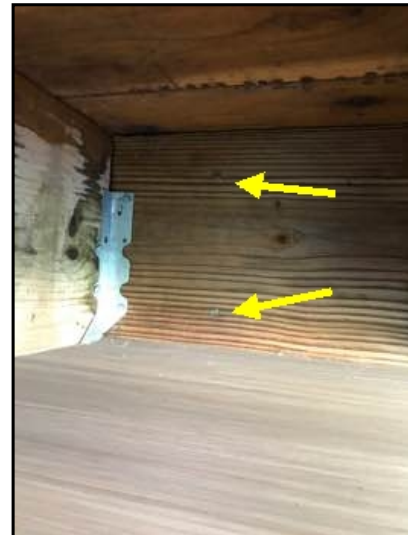
Ledger board anchored to house with deck screws. Lag screws are recommended.

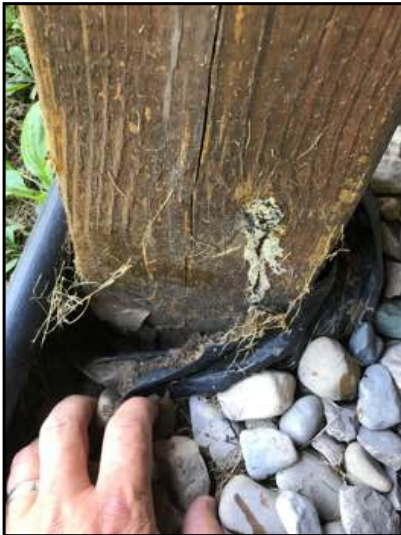
- Attached wood Deck.
- Composite deck.
- Block patio.
- Ledger board attached to house with visible flashing.
- IMPROVE: Wood deck supports are in contact with the ground, which can cause premature wood deterioration. No wood deterioration was visible at ground level.

Wood to ground contact. footings were not visible or accessible.

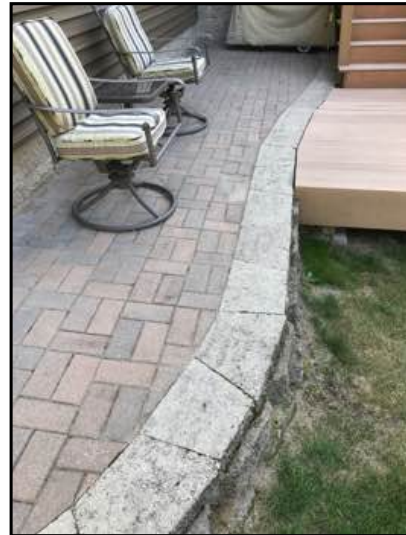
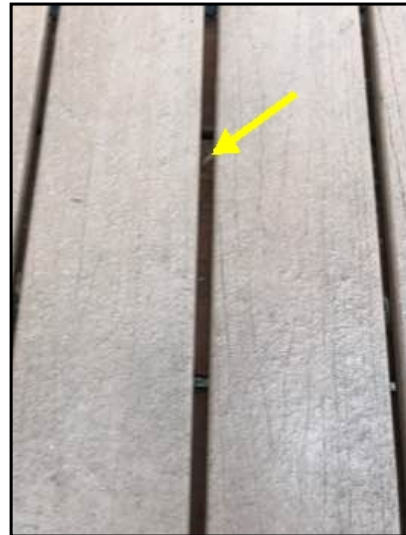
Composite decking installed over finished wood decking.

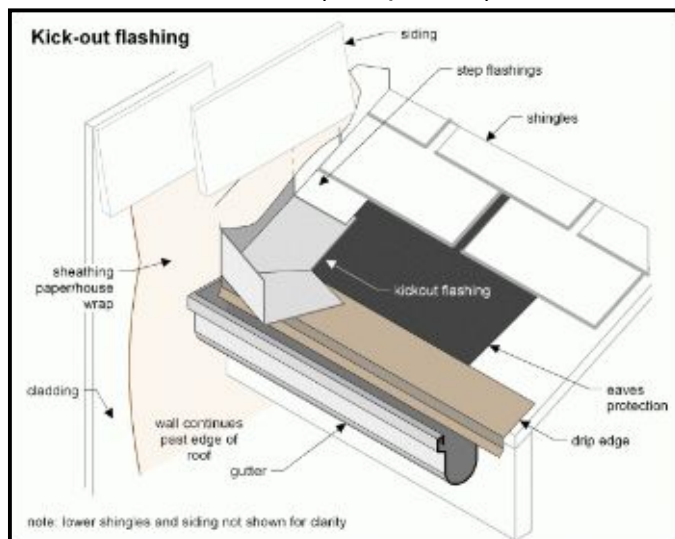
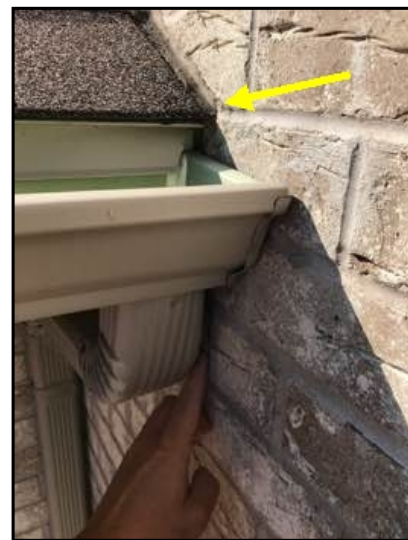
- All accessible plumbing vent flashings were in good condition at the time of inspection.
- Rubber type boots are installed at plumbing vents. These typically do not last as long as the roof covering materials (shingles). Consider checking the condition as part of an annual maintenance check, and replace as necessary.
- **VALLEYS:**
- Visible portions of **valley flashings** observed to be functional at time of inspection.
- **IMPROVE:** Consider installing a kick out flashing at roof/wall connections. Over time, a small amount of water will miss the gutter at these areas and run down the brick/siding. There is 1 loose brick face above the small garage door, which is likely from water wicking in to the brick and freezing. (see picture)

Brick spalling due to missing kick out flashing above garage door.

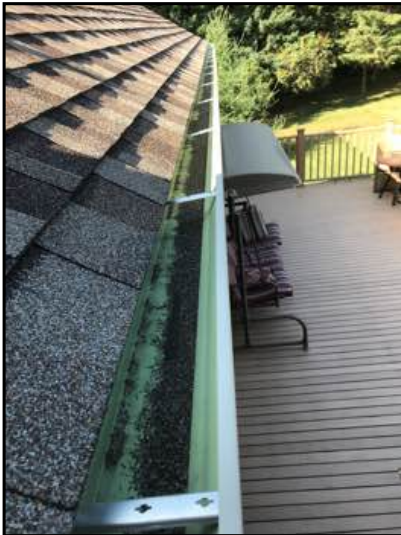
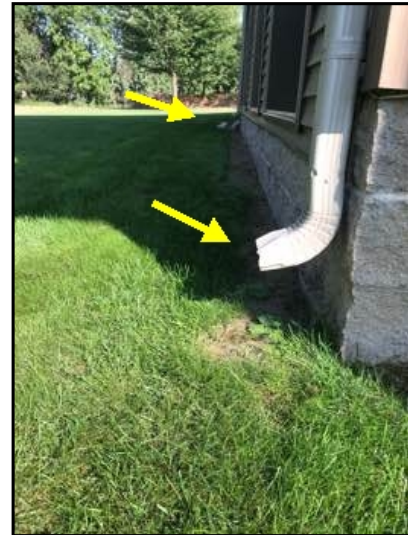
Downspout extensions recommended. North.

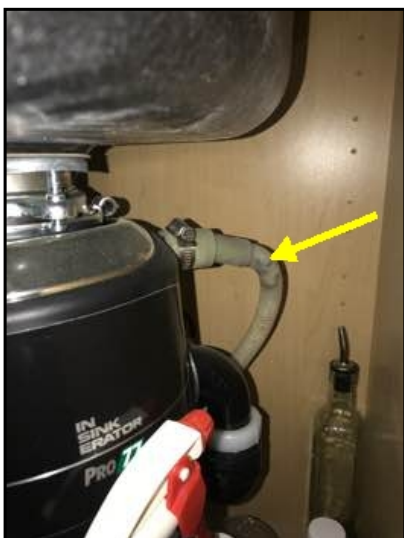
- Dishwasher was operational at the time of inspection. Dishwashers most commonly fail internally at the pump, motor or seals. We do not disassemble these units to inspect these components. We recommend you operate this unit prior to closing.
- IMPROVE: Dishwasher drain line is lacking a high loop/**air gap** for drainage. <https://removeandreplace.com/2016/04/07/dishwasher-high-drain-loop-and-air-gap-anti-siphon/>

No high loop on dishwasher drain.

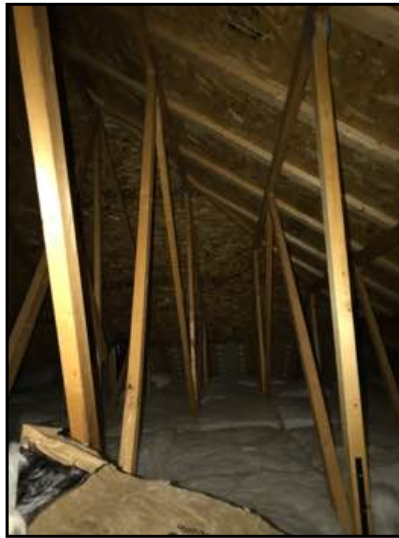
- **IMPROVE:** The attic access panel was not insulated. Recommend installing insulation on the top side of panel to eliminate energy loss through hatch. Studies have shown that this condition creates a huge vacuum where heat quickly escapes into the attic.

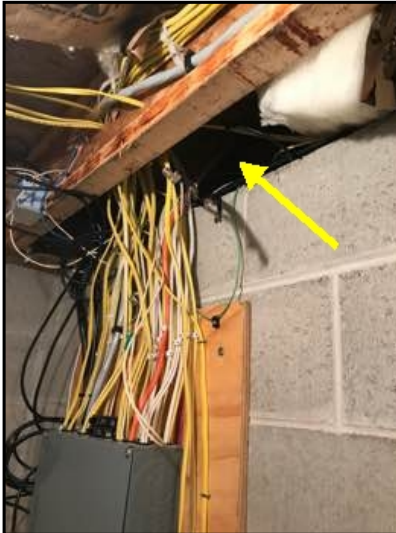
- **IMPROVE:** Perimeter insulation was observed to be missing or out of place at one or more joist bay locations. Recommend repair/replacement to promote enhanced resistance to heat loss which will increase the efficiency of the home and lower heating costs.

Missing insulation above electrical panel.

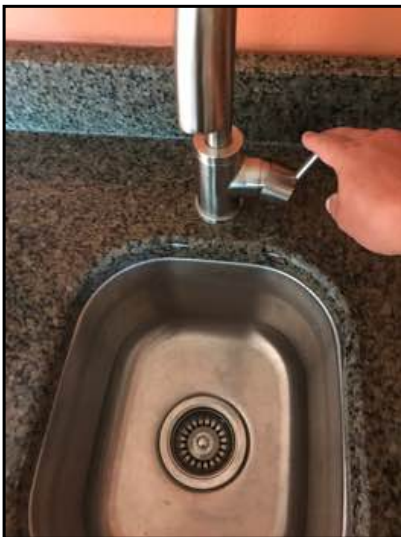
Basement sink supply lines were shut off. No water at sink. Not tested.

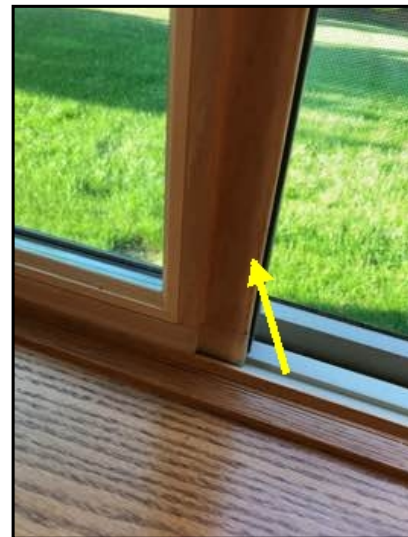
1 sliding window was unfinished

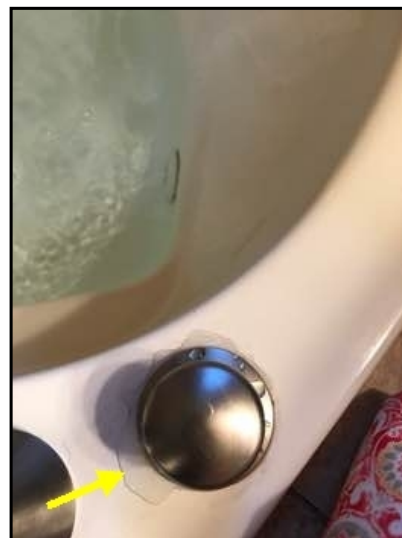
- **\*\*SHOWER BASE\*\***
- Tiled shower base observed, we are unable to determine if a proper shower pan has been installed. No leaks observed at time of inspection.
- Observed to be in good visual condition, and functioning as intended.
- **\*\*SHOWER FAUCET\*\***
- Functional.
- **\*\*JET TUB\*\***
- Operated normally- Small amount of water leaks from shower head diverter when pressed. Likely from a worn or loose gasket. Repair is recommended.

Shower head control has a small leak when depressed for shower head.

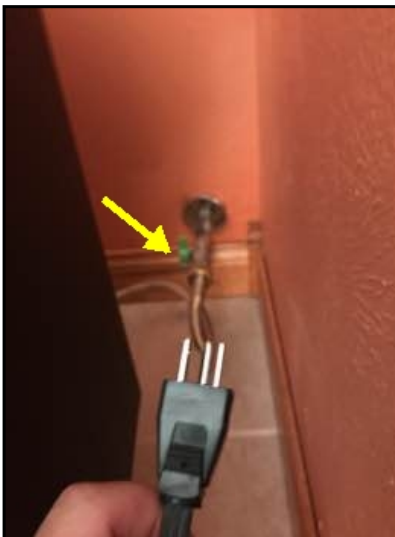
- Gas fireplace was not functional during the inspection. Possibly due to gas being shut off or pilot not being lit. Refer to condition report for more information.

Gas fireplace was unplugged and gas turned off. Not tested.

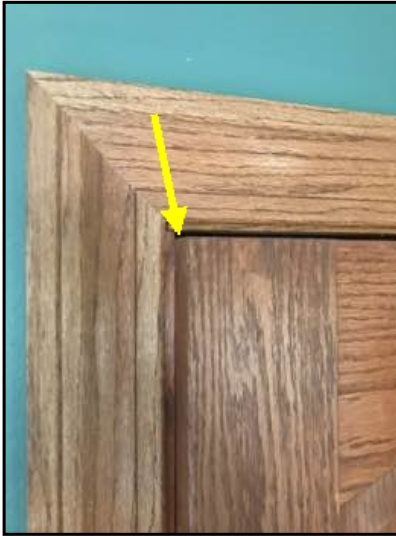
Door binding in frame at top corner.

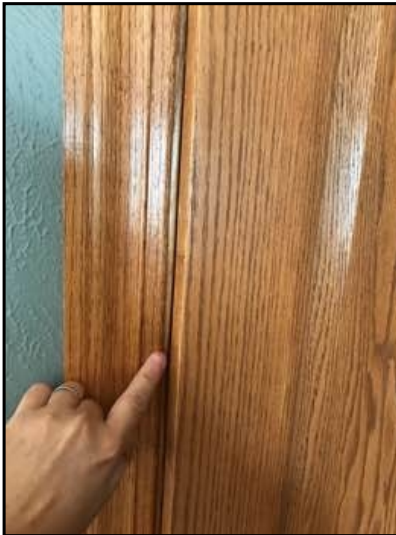
- LOCATION:
- Lower West.
- All accessible areas of walls and ceilings were observed to be in good visual condition at the time of inspection.
- All accessible windows were functioning as intended.
- IMPROVE: Door binding in frame. Will need adjustment to close properly.

Door did not close completely. Needs adjustment.
