# *Safeguard Home Inspection LLC*

## Property Inspection Report

1700 41st Ave, Anytown, WI 12345  
Inspection prepared for: Joe Smith  
Real Estate Agent: Private sale inspection -

Date of Inspection: 8/23/2018 Time: 8:00  
Age of Home: 2007 Size: 2744

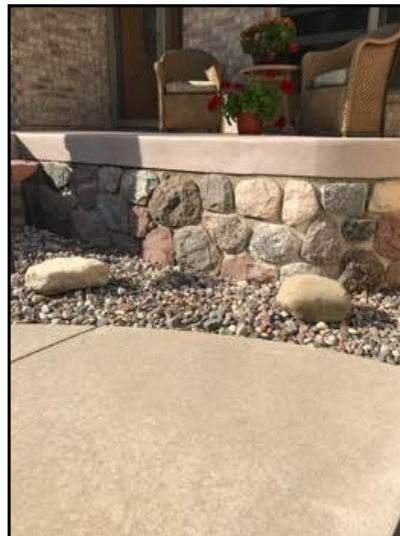
Gap in mortar. SW corner.

- No major system safety or function concerns noted at time of inspection.
- Caulk and seal all gaps, cracks and openings.

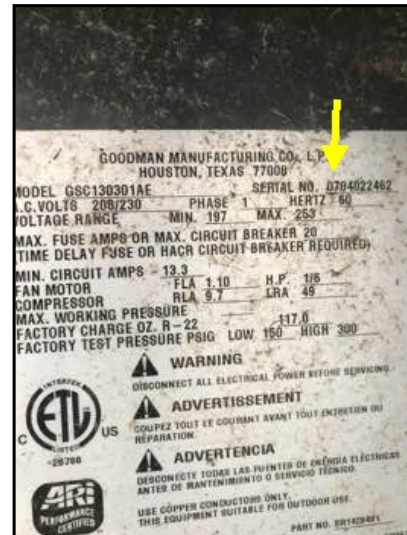
Manufacture Date: April/2007

- **LOCATION(S):**
- West side of house.
- **CONDITION:**
- Unit is level.
- Dirty. Recommend removing grass and vegetation from the unit to increase efficiency.
- Functioning at the time of inspection.
- The average service life for **A/C** unit is 10-15+ yrs. Although some last much longer with proper maintenance and yearly service. This report is not a guarantee of the life expectancy of this unit.

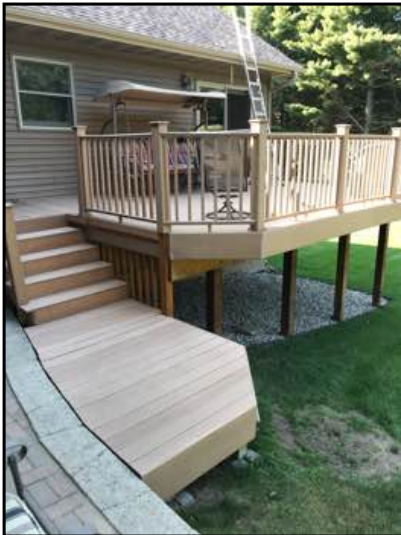
Composite decking installed over finished wood decking.

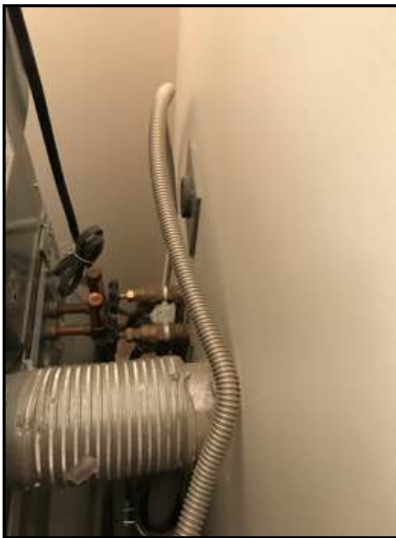
- Most not accessible. Shut offs observed. Not tested for function.
- Flex drain observed, these are subject to frequent clogging.

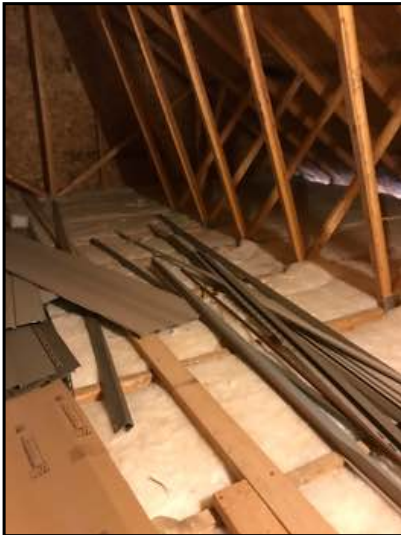
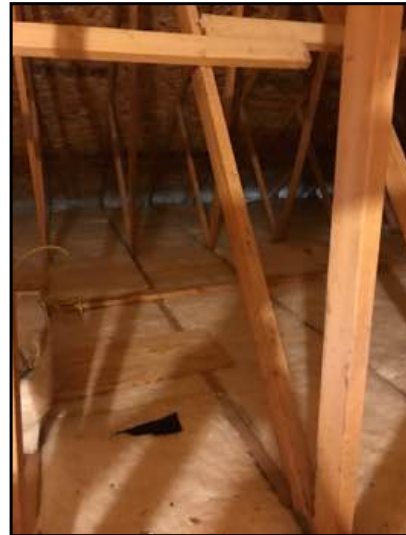
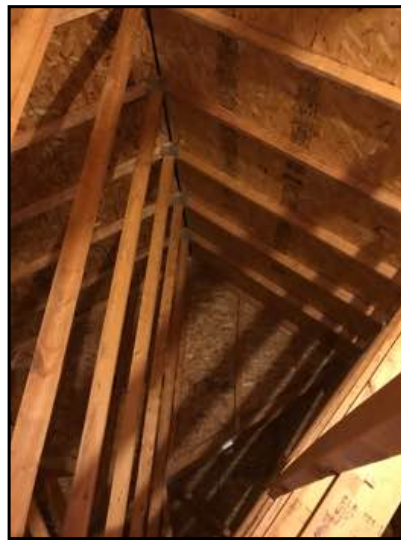
- INSPECTED FROM:
- Due to limited access, the attic was inspected from the scuttle hole.
- Lighting is present and functional.
- The attic is insulated.
- All accessible framing materials were in good visual condition at the time of inspection. No apparent leaking or damaged framing observed.
- ELECTRICAL:
- All accessible electrical components/wiring/outlets/fixtures were in good visual condition and functioning as intended.

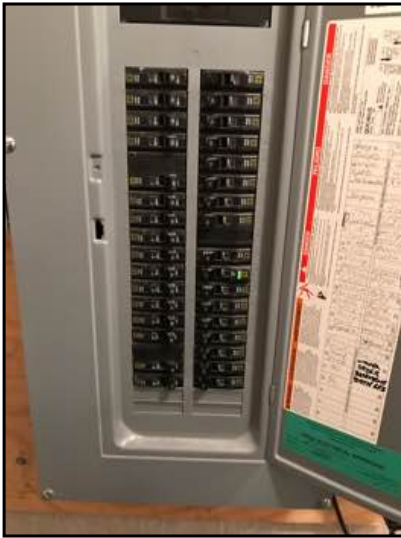
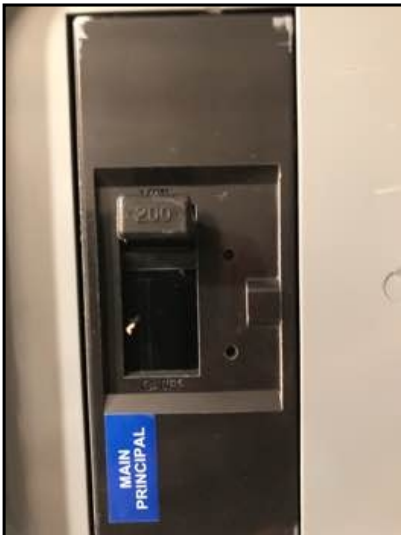
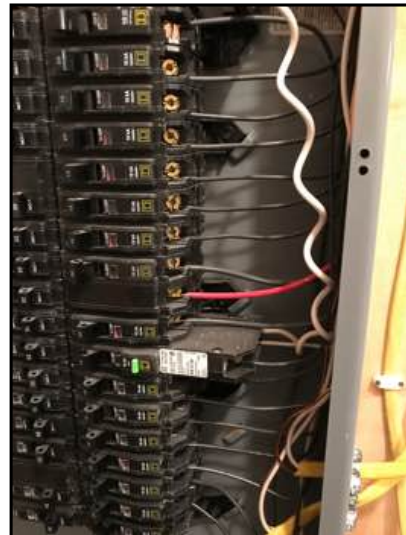
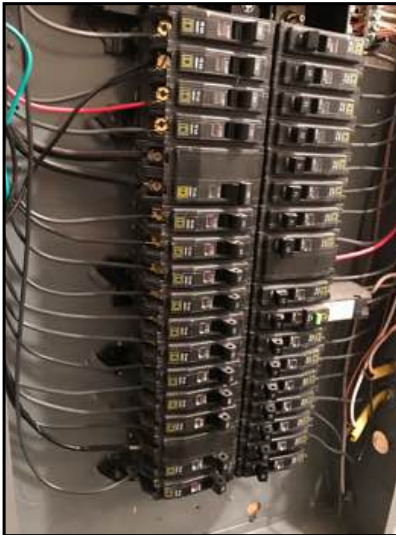
- No major system safety or function concerns noted at time of inspection at main panel box. Proper grounding and bonding confirmed.

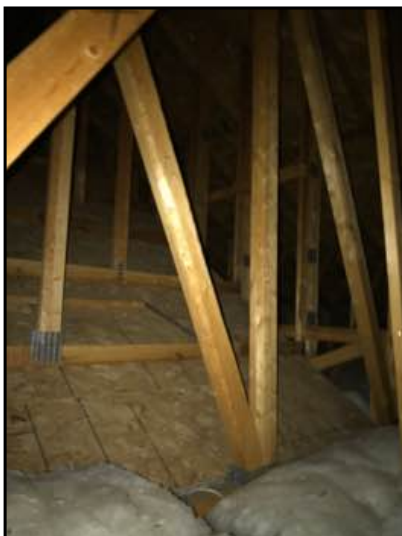
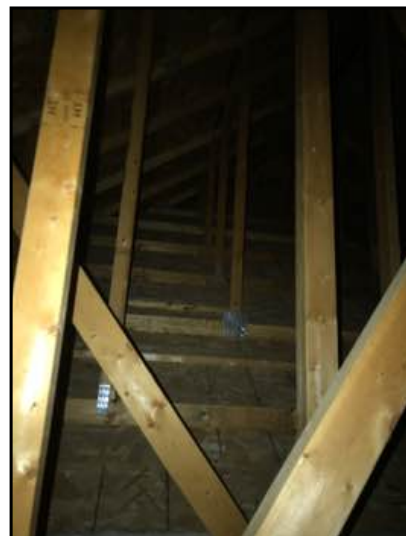
- All accessible framing components were observed to be in good visual condition at the time of inspection.

- Manufactured trusses.

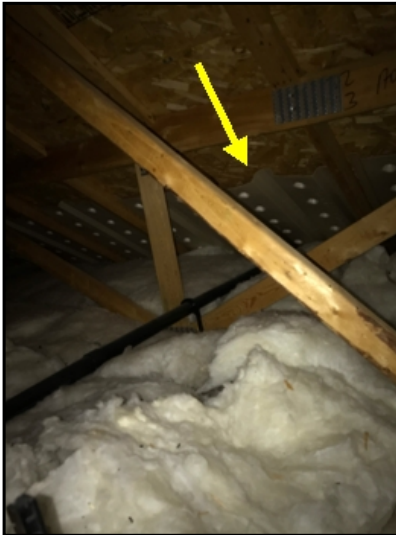
Soffit vent baffles.

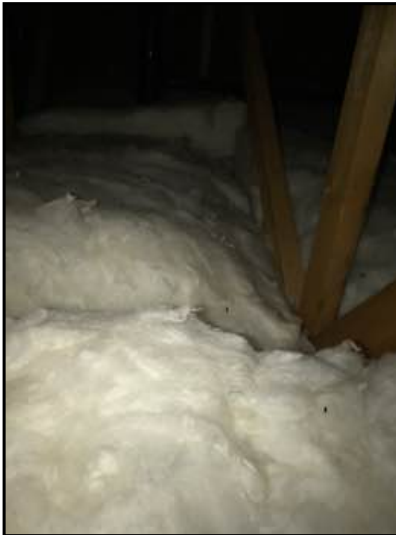
- Insulation appears adequate.

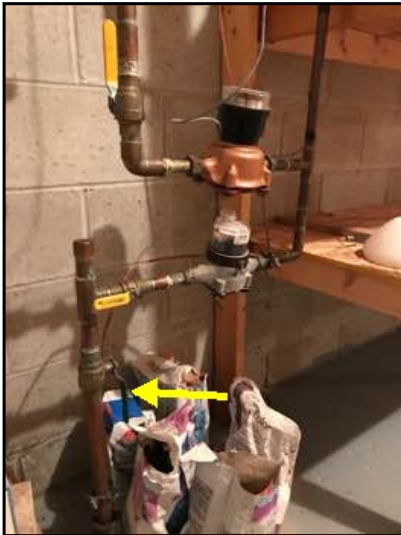
Main water supply shut off.

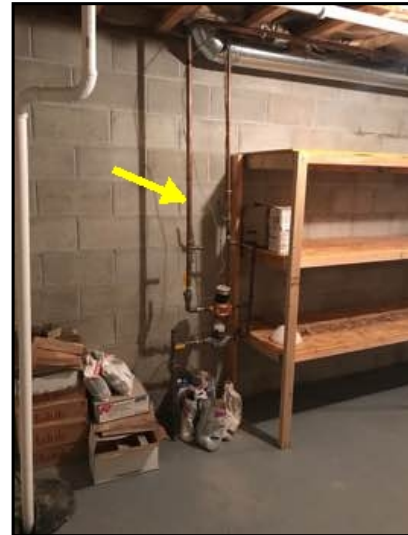
2nd line feeds irrigation system.

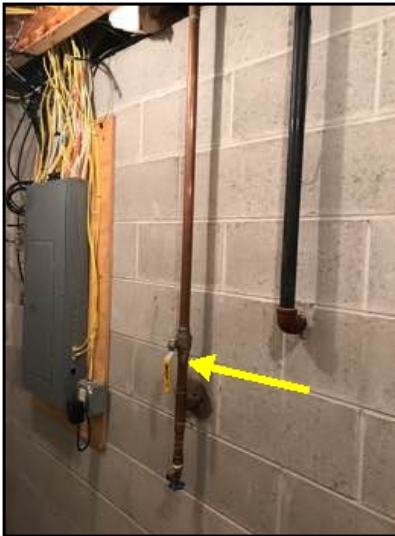
Water shut off for irrigation system.

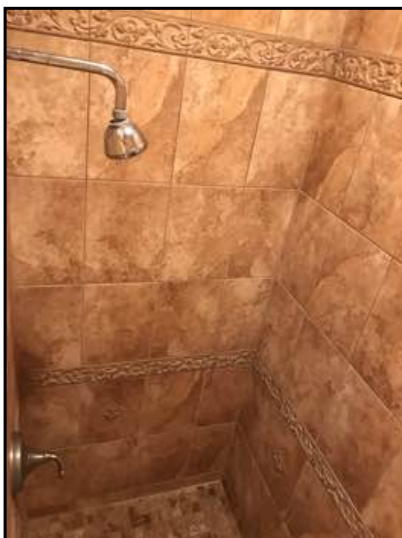
Tiled shower stall.

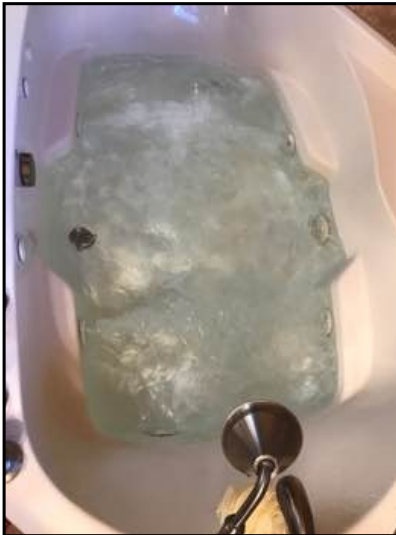
Jets were all working properly.

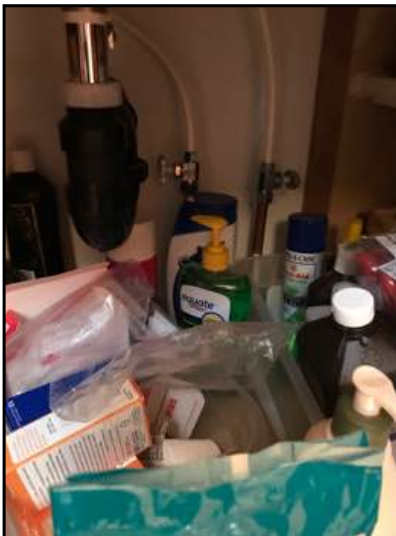
- Operated normally, at time of inspection.
- Shutoffs are present under the sink. Not tested for function.

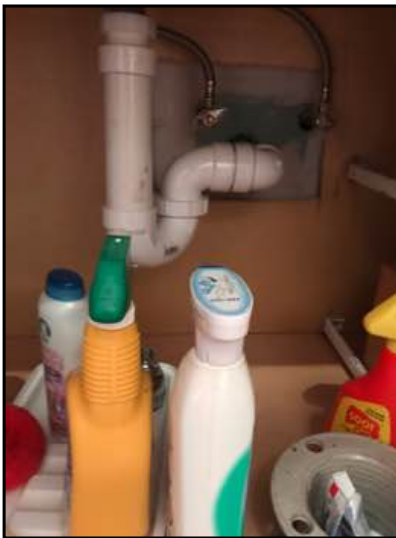
- **CONDITION:**
- Sink observed to be functional and in good visual condition at the time of inspection.
- **\*\*DRAINS\*\***
- Functioning as intended, at the time of inspection.
